# Influence of lateral impact on reinforced concrete piers under drying-wetting cycle and chloride ion corrosion environment

W.Y. Dong<sup>a</sup>, C.Q. Fang<sup>b,\*</sup> and S. Yang<sup>c</sup>

**Abstract.** In order to study the influence of lateral impact on reinforced concrete piers in marine environment, drop hammer impact tests were carried out on piers with different corrosion rates obtained from drying-wetting cycle and chloride ion corrosion experiment to study the crack propagation process and failure modes of piers. Then by numerical simulation, the influences of impact velocity, impact mass, compressive strength of concrete and impact number on the performance of corroded piers were studied. The results showed that the failure modes of piers with different corrosion rates under lateral impact were different. The non-corrosive and low corrosion rate piers were destroyed by the bending shear which was jointly controlled by the transverse bending crack and oblique shear crack. The medium corrosion rate pier was the bending shear failure caused by oblique shear crack. The high corrosion rate pier was the joint action of bending shear crack and rust expansion crack. The

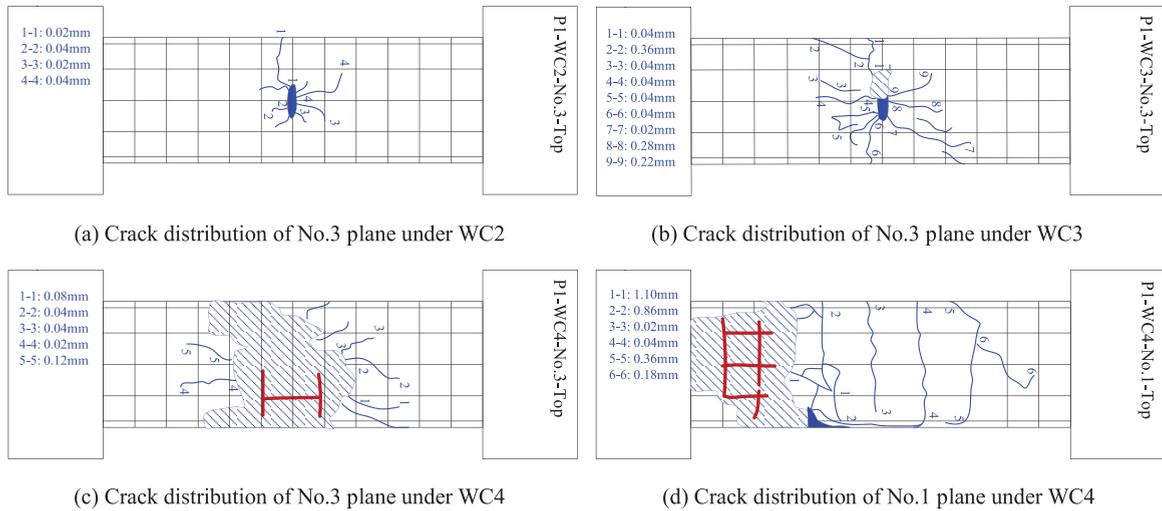
Fig. 6. Crack distribution of specimen P1.

**2.4.1.1 Non-corrosive specimen:** A total of 4 drop hammer impacts (WC1-WC4) were carried out on P1 specimen. After WC1, only 2 short cracks were appeared on the No.3 plane and the maximum crack width was 0.04 mm. After WC2, four cracks were radially distributed in the impact zone of No.3 plane. The cracks spread radially outward around the impact zone after WC3, with 9 cracks being observed and the maximum width of the crack increased to 0.36 mm. Oblique cracks extending from the impact zone to the support appeared on the No.2 and No.4 planes. The maximum crack width was 0.38 mm. After WC4, concrete was crushed in the impact zone and the large block stripping fell off along the oblique shear crack direction. The internal longitudinal bar and hoop were exposed, and the longitudinal bar of the impact plane was bent. Longitudinal cracks and oblique cracks were further expanded from the impact zone to the two ends of the pier, with the maximum crack width being of 1.2 mm. The concrete at one end of the No.1 plane was also peeled off, and the crack with maximum width of 0.86 mm appeared through the transverse bending of the pier. Representative crack distributions of specimen P1 are shown in Fig. 6(a)-(d). The blue solid line indicates the crack in the pier. The slash shadow area is the concrete peeling area. The blue shadow area is the impact area. The red coarse line indicates the exposed steel bar inside the pier.

The failure of non-corrosive reinforced concrete pier under lateral impact is a process in which the cracks develop gradually from the impact zone uniformly to both ends of the specimen with the increase of impact height. The failure mode is the bending shear failure caused by the joint development of transverse bending cracks in the tensile zone of the specimen and oblique shear cracks in the shear span zone.

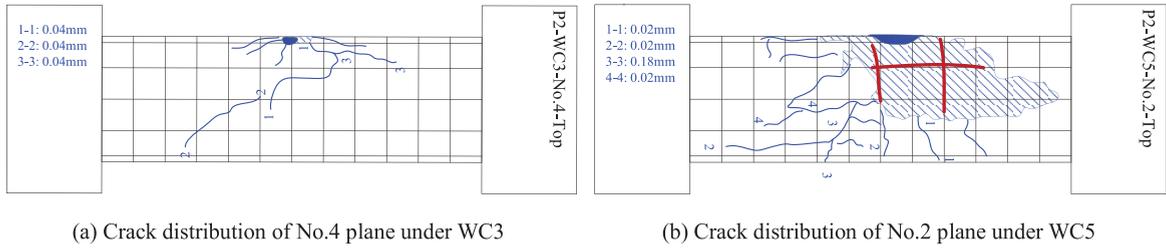
Fig. 7. Crack distribution of specimen P2.

with corrosion rate of 3.1% were studied. A total of 5 drop hammer impacts (WC1-WC5) were carried out on P2 specimen. After WC1, 7 fine and radial cracks around the impact zone can be observed on the No.3 plane and the maximum crack width was 0.04 mm. After WC2, the concrete crushing in small area appeared on the No.3 plane and the width of crack increased to 0.16 mm. After WC3, the cracks on the No.3 plane were observed increase in number and width, with crack width increased to 0.42 mm. The oblique cracks from the impact zone of upper surface to the bottom of the corrosion zone can be observed on the No.4 plane, and the maximum crack width was only 0.04 mm with the angle of 45° from the horizontal direction. After WC4, the concrete in the pressurized zone was peeled off and the steel bar in impact zone was exposed, and the side oblique shear crack and the transverse bend crack appeared simultaneously. For WC5, the impact height was 2.00 m. The concrete on both sides of the pier showed different degrees of spalling, and the oblique shear cracks and transverse cracks continued to expand until connected through the whole pier. After WC5, the specimen was shown as the bending shear failure which is controlled by the oblique shear crack and the transverse bending crack. Representative crack distributions of specimen P2 are shown in Fig. 7(a)-(b).

Failure mode of the specimen with low corrosion rate is also the bending shear failure controlled by both transverse bending crack and oblique shear crack. Different from non-corrosive specimen, the crack width of specimen with low corrosion rate is smaller than that of non-corrosive specimen under same working condition, and the impact numbers of the specimen bearing impact load is more than that of non-corrosive specimen. The crack propagation process changes from uniform to both ends of specimen to the corroded end of specimen. Main reason for this phenomenon is that when the steel bar has a small amount of corrosion, the corrosion products produced fill the gap between the steel bar and concrete, thus enhancing the bonding force between steel bar and concrete and improving the anti-lateral impact performance of specimen.

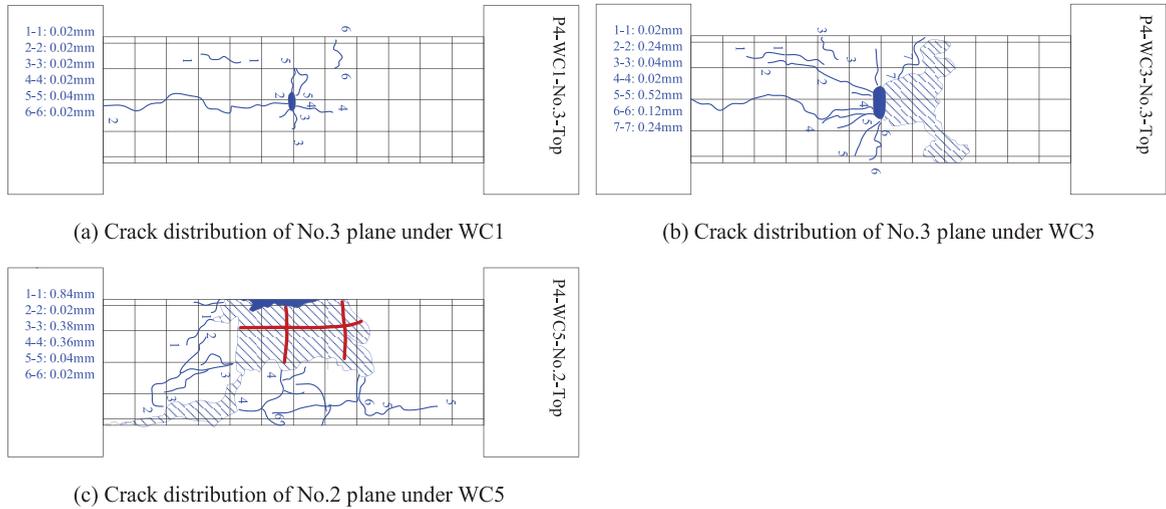
Fig. 8. Crack distribution of specimen P4.

out on P4 specimen. After WC1, 1 crack along the longitudinal bar can be observed extending from the impact zone to the bottom of the pier column. The fine cracks in the impact zone were radial, and the maximum width of the crack was 0.04 mm. After WC2, more cracks were observed in the impact zone and the maximum crack width increased to 0.18 mm. After WC3, the crushing and peeling of concrete appeared in the impact zone. Two main oblique cracks can be observed on the No.2 plane and its maximum crack width was 0.48 mm. After WC4, the protective layer of concrete in the impact zone was seriously peeled off and the oblique cracks continued to develop on the side of pier. After WC5, in the compression zone of concrete, large blocks peeled off along the direction of oblique shear. Longitudinal bar and stirrups in the impact zone exposed and 2 stirrups fractured. The oblique shear crack, transverse bending crack and longitudinal crack were interlocked. The maximum crack width was 0.84 mm. Representative crack distributions of specimen P4 are shown in Fig. 8(a)-(c).

Failure mode of the specimen with medium corrosion rate is the bending shear failure controlled by oblique shear cracks. Compared with non-corrosive and low-corroded specimens under the same working conditions, with the increase of corrosion rate, the crack width of specimen increased, but the number

of cracks decreased. With the increase of impact height, the oblique shear crack of specimen developed rapidly, and the crushed concrete of specimen also developed further from impact zone, resulting in spall along the oblique shear area, and finally led to the bending shear failure of specimen dominated by the oblique shear cracks.

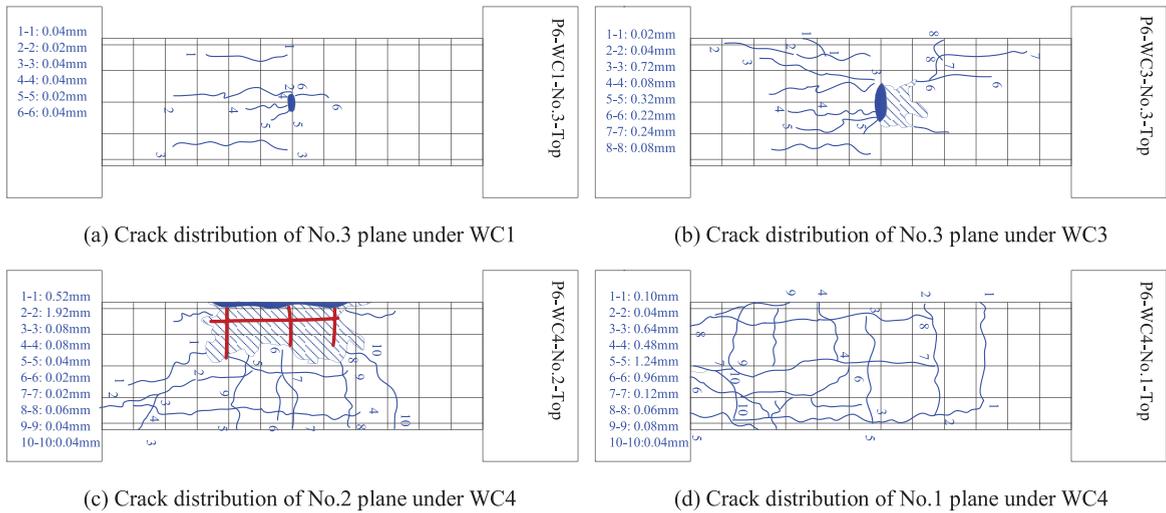
Fig. 9. Crack distribution of specimen P6.

**2.4.1.4 High corrosion rate specimens:** The crack propagation process and failure mode of P6 specimen with corrosion rate of 10.1% was studied. A total of 4 drop hammer impacts (WC1-WC4) were carried out on P6 specimen. After WC1, 6 fine cracks along steel bar with a maximum crack width of 0.04 mm could be observed on the No.3 plane. After WC2, the cracks were radially distributed along the impact zone, and the crack width increased to 0.12 mm. After WC3, concrete peeling slightly in the impact zone of the specimen. Cracks on the No.3 plane continued to expand. The width increased to 0.72 mm. On the No.4 plane, 6 oblique cracks which tended to be horizontal and with the maximum width of 0.08 mm could be observed. After WC4, large blocks of concrete were stripped off and steel bar was exposed. Many oblique shear cracks and transverse bending cracks appeared in the corroded zone of the pier. The maximum crack width was 1.92 mm. Rust expand cracks along longitudinal bars could also be observed. Representative crack distributions of specimen P6 are shown in Fig. 9(a)-(d).

Under multiple lateral impacts, a large number of cracks along the longitudinal bar direction and transverse bending and oblique shear cracks through the specimen were appeared on the specimen with high corrosion rate. The failure mode was the joint action of bending shear cracks and rust expansion cracks. The main reason for this failure mode is that, with the increase of corrosion degree of reinforcement, the increase of expansion products leads to the decrease of bond performance between reinforcement and concrete, and produce rust expansion cracks along direction of the longitudinal bar, which reduces the lateral impact resistance of the specimen.

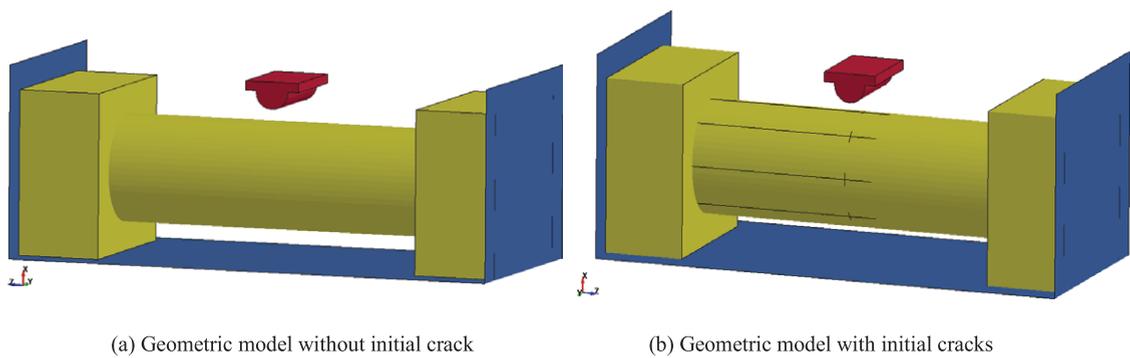
Fig. 10. Geometric models of the reinforced concrete pier.

concrete pier. But for corroded specimens, there were cracks along the longitudinal steel bar on the concrete surface. Therefore, the micro-cracks which along the longitudinal steel bars were preset in the geometric model. The geometric models were shown in Fig. 10.

In the geometric model, the length of longitudinal steel bar is 82 cm. For the drying-wetting cycle and chloride ion corrosion specimens, all the longitudinal bars in the position of 0–35 cm belongs to chloride ion corrosion segment, 35–46 cm belongs to the drying-wetting cycle and chloride ion corrosion segment, 46–82 cm belongs to non-corrosive segment. In order to simulate the different segments, the longitudinal bars in the model are modeled in segments and given different diameters.

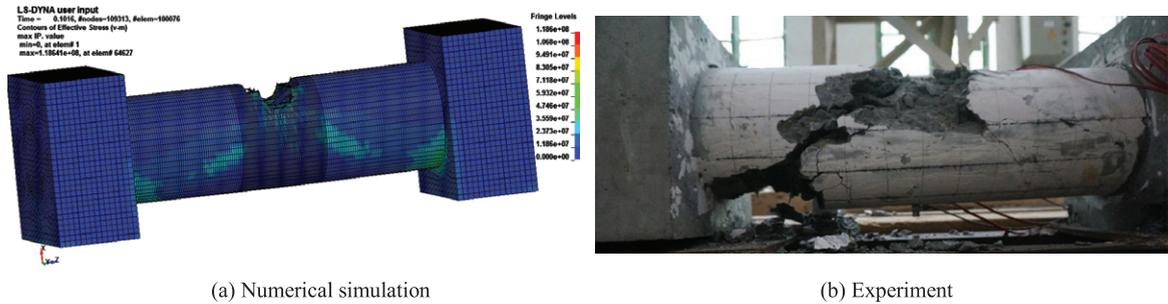
Fig. 11. Damage results of P1 specimen.

simulation, we carried out numerical simulation on P1 specimen corresponding to impact test WC1-WC4. After WC4, the damage results of numerical simulation and experiment were shown in Fig. 11 (a) and (b) respectively. By comparing the damage results of P1 specimen obtained by numerical simulation and experiment, it can be seen that the damage was basically the same and was as follows: In the impact zone, concrete was crushed and large pieces spalled off. There were obvious oblique cracks extending from the impact zone to both ends of the pier. The coterminous part of pier column and abutment appeared to be damaged. Therefore, numerical simulation can be used to study the influence of various factors on the performance of corroded piers under impact.

On the other hand, we compared the damage results between numerical simulation and experiment. In order to further verify the feasibility of numerical

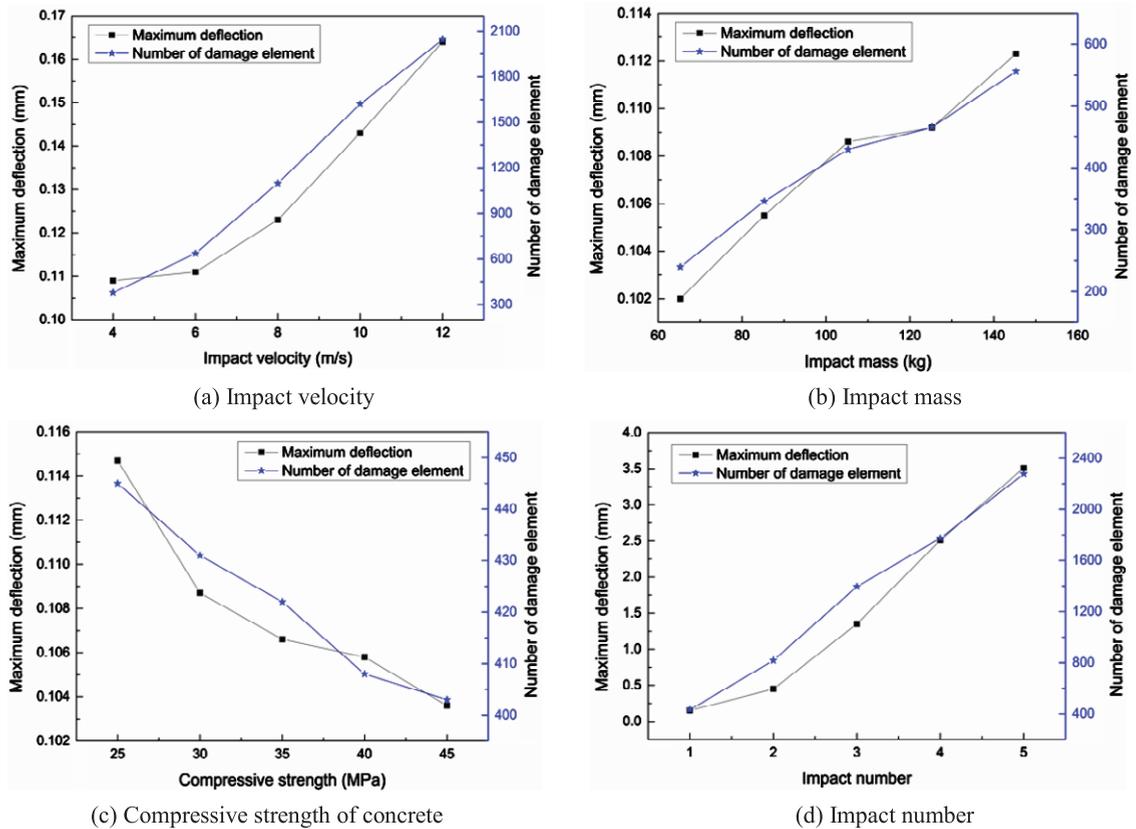
Fig. 12. Influence of different factors on maximum deflection and number of damage element of pier.

It can be seen from Fig. 12(a), with the increase of the impact velocity, the number of damage element and maximum deflection of the pier increased significantly. Compared with the standard working condition (impact velocity of 4m/s), when the impact velocity was 1.5, 2, 2.5 and 3 times of the impact velocity under standard working condition, the maximum deflection of the pier increased by 1.5%, 12.9%, 31.7% and 50.6%. When the impact velocity increased from 4 m/s to 6 m/s, 8 m/s, 10 m/s and 12 m/s, the number of damage elements increased by 0.68, 1.90, 3.29 and 4.40 times, respectively. Numerical simulation results showed that increasing the impact velocity will obviously increase the damage of lateral impact on the corroded pier.

It can be seen from Fig. 12(b) that the number of damage elements and the maximum deflection of the pier changed with the change of impact mass. Compared with the standard working condition (impact mass of 105.3 kg), when the impact mass decreased by 19% (85.3 kg) and 38% (65.3 kg) respectively, the maximum deflection of the pier decreased by 2.9% and 6.1%, while the impact mass increased by 19%

(125.3 kg) and 38% (145.3 kg) respectively, the maximum deflection of the pier increased by 0.6% and 3.5% respectively. From Fig. 12(b), it also can be seen that the number of damage elements increased significantly with the increase of the impact mass. The impact mass increased from 65.3 kg to 145.3 kg, the number of damage element increased from 240 to 556, increased by 1.3 times. It is concluded that the impact mass affects the performance of the corroded pier under the lateral impact, and with the increase of the impact mass, the impact damage of the corroded pier becomes larger.

As can be seen from Fig. 12(c), changing the compressive strength of concrete will affect the maximum deflection and the number of damage element of corroded pier under lateral impact, but with less degree. Compared with the standard working condition (concrete compressive strength of 30 MPa), the maximum deflection of pier with concrete compressive strength of 25 MPa increased by 5.5%, while the maximum deflection of piers with concrete compressive strength of 35 MPa, 40 MPa and 45 MPa decreased by 1.9%, 2.8% and 4.6%, respectively. With the increase of concrete compressive strength from 25 MPa to 45 MPa, the number of damage element decreased from 445 to 403, decreased by 9.44%. In conclusion, it can be concluded that, the compressive strength of concrete has little influence on the performance of corroded pier under lateral impact.

As can be seen from Fig. 12(d), the impact number has a great influence on the number of damage element and the maximum deflection of the pier. Increasing the impact number, the maximum deflection and the number of damage element of the pier both increased obviously. When the impact number increased from 1 to 2, 3, 4 and 5, the maximum deflection of the pier increased by about 2.2, 8.8, 15.8 and 26.3 times, respectively. It can be concluded that when the impact number was small ( $\leq 2$ ), there was a linear relationship between the increase times of deflection and the impact number, but when the impact number was more than 2, there was a linear relationship between the increase times of deflection and the square of impact number. When the impact number increased from 1 to 2, 3, 4 and 5, the number of damage element increased from 432 to 818, 1396, 1774 and 2277, increased by about 1, 2.2, 3.1 and 4.3 times, respectively. In conclusion, the impact number has significantly influence on the performance of corroded pier under lateral impact.

simulation was carried out with the impact velocity of 4 m/s, 6 m/s, 8 m/s, 10 m/s and 12 m/s respectively. The number of damage element and the maximum deflection of the pier at different impact velocities were shown in Fig. 12(a).

In order to study the effect of impact mass on performance of pier, the impact mass was changed under the condition that other conditions in standard working condition were unchanged. Then, the numerical simulation was carried out with the impact mass of 65.3 kg, 85.3 kg, 105.3 kg, 125.3 kg and 145.3 kg respectively. The number of damage element and the maximum deflection of the pier under different impact mass were shown in Fig. 12(b).

concrete compressive strength were shown in Fig. 12(c).

was impacted five times under standard working condition. The number of damaged element and the maximum deflection of pier were recorded after each impact and as shown in Fig. 12(d).
