Tragedy on grade crossing: driver failure or systemic fragility?

Abstract. In 2010, an accident occurred in Americana-SP, Brazil, involving two trains and one bus on a Grade Crossing, when 10 people died and 17 were injured including workers. This paper aims to analyze the accident using the Model of Analysis and Prevention of Work Accidents (MAPA). The method provides observation of work, interviews and analysis of documents to understand precedents of the event in the following stages: to understand the usual work from the involved people, the changes occurred in the system, the operation of barriers, managerial and organizational aspects. By the end, measures are suggested to avoid new occurrences. The accident took place at night in a site with insufficient lighting. The working conditions of bus drivers, train operators and watchmen are inadequate. There were only symbolic barriers (visual and acoustic signals) triggered manually by watchman upon train operator radio communication. The fragility of the barrier system associated to poor lighting and short time to trigger the signaling seem to play a critical role in the event. Contrary to the official report which resulted in

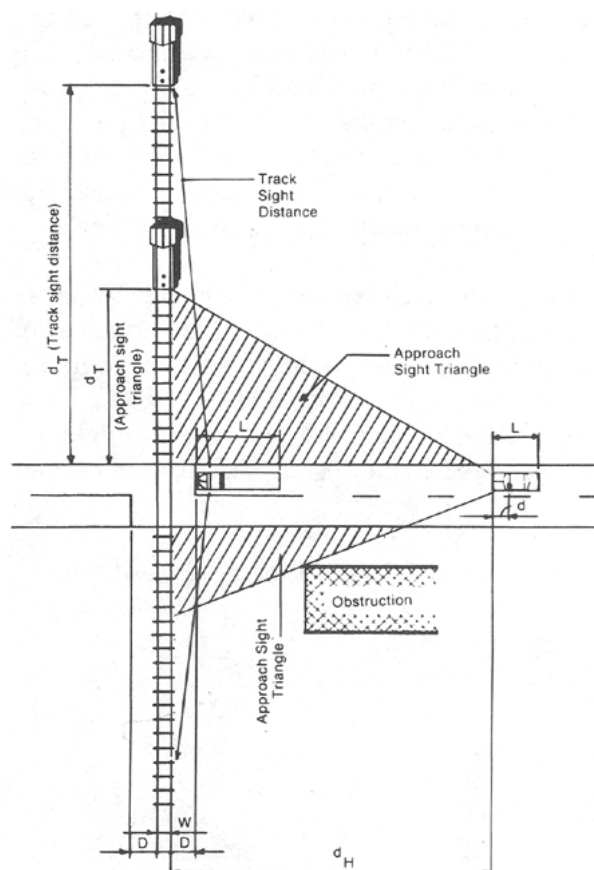
According to Federal Highway Administration [8], three sight distances of the train are considered on a grade crossing: a) the distance in front of the crossing; b) distance along the track in which a train can be approaching the crossing from any direction; c) sight distance along the tracks in any direction of a vehicle stopped on the crossing (Fig. 1).

Fig. 1. Sight distances for crossing on a grade crossing. Source: Railroad-Highway Grade Crossing Handbook, Second Edition. Washington, DC: U.S. Department of Transportation, Federal Highway Administration, 1986.

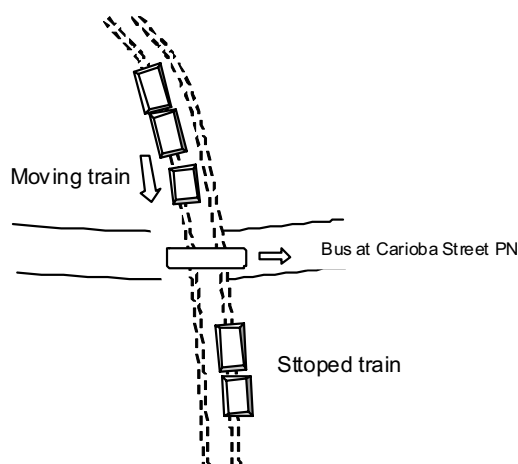
The bus was hit on the GC by a train coming from the left towards the right and pushed against another train parked about 100 meters to the right. According to the bus driver's report, the traffic light was red when the vehicle was in the middle of the GC. Figure 2 presents diagram of the GC, the location of two trains and the bus at crossing moment on the GC resulting the accident.

Fig. 2. Diagram of the accident site.

The site is poorly lit what hampers the visualization of trains coming from the left. Besides this, there are buildings under construction next to the GC, that obstruct the visualization of the trains coming to it, at the crossing moment. At this site one can also find out the land presents strong undulations near by the tracks, calling the drivers for decreasing the speed of vehicles during the crossing of railway track.

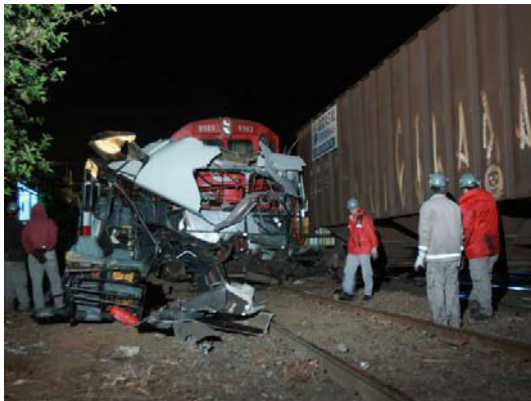
The accident took place at night (Fig. 3), at about 11:25P.M., a few hours before the train was supposed to be withdrawn. On the GC there is heavy traffic of cars, motorcycles, buses and pedestrians (Fig. 4). After two months of the accident, a manual gate was installed to block the traffic of people and vehicles during the crossing of trains on the GC. This gate is closed manually by the watchman who stays on duty upon train operator radio communication, who warns when he's approaching and he's going to cross the GC.

Fig. 3. Picture of the Accident in Americana-SP.
Source: Macedo, 2010.

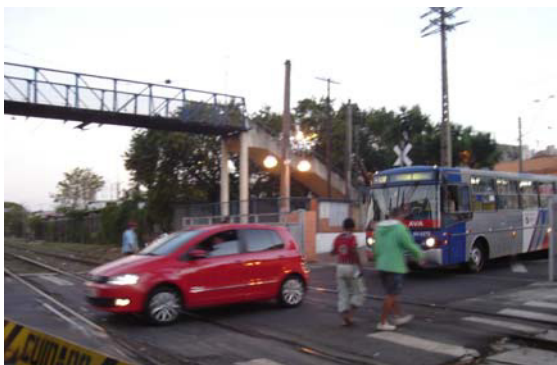
Fig. 4. The dynamics of the Grade Crossing in Americana-SP.

Nowadays, when the train is 2 or 3km away from the GC, the train operator warns the watchman by radio communication if he is going to cross the GC or to stop before it. The watchman is supposed to the triggering of the light and sound signal when he receives the warning that the train is going to surpass the GC, and after the accident he is due to close manually the gate. The train operator is supposed to trigger the train horn 500 meters away from the GC.

Even with the signal triggered it is perceptible that people nowadays cross this signal while the gate is not completely closed. It occurs in the same way when the watchman opens the gate after the train passing, and some seconds after the opening of the gate the vehicles pass very close to the watchman, who is in danger of being run over.
