3M Brazil ergonomics: a success story in the making

Abstract. The aim of this project is to present two case studies and provide job assessment results, share implemented solutions, and provide information about realized cost and benefits. In this session, two cases studies, one from São José do Rio Preto and the other from Sumaré, will be presented. These projects won AEIA awards in 2009 and 2010, respectively. The projects describe the application of the Ergonomic Risk Reduction Program, which both improves worker's quality of life and productivity and product quality as well.

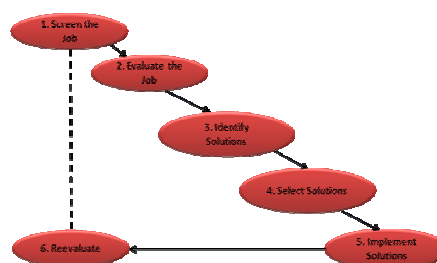
Fig. 1 Ergonomics Risk Reduction Process

One aspect of the program, 3M's Ergonomics Risk Reduction Process (ERRP), is a systematic process of identifying, prioritizing, assessing, and reducing unacceptable ergonomics risk in jobs throughout 3M's manufacturing and distribution operations, see Fig. 1. The ERGO Job Analyzer (EJA) tool provides a consistent, objective methodology to identify and quantify ergonomics risk exposure in all 3M manufacturing and distribution operations. The experience in Brazil demonstrates that the ERRP and ergonomics job assessment tool also help the company comply with the Brazilian Ergonomics Standard NR-17.

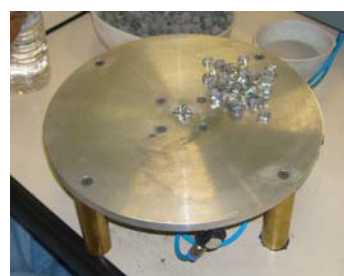
Figure 2: New Machine – semi-automatic

The force required by the employee and the awkward postures were eliminated through the process redesign and change in the way that the employee performs the task.

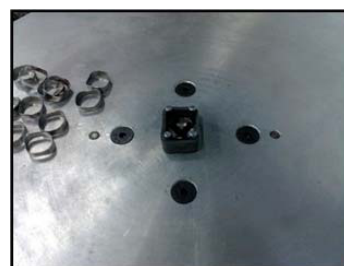
Figure 3: New Machine – After opening the 4-pins

A new EJA assessment was applied. The results: the high risk was totally eliminated, and productivity was increased by 100%. Three old machines were eliminated by the new machine.
